20. Troubleshooting

O-ring Failure

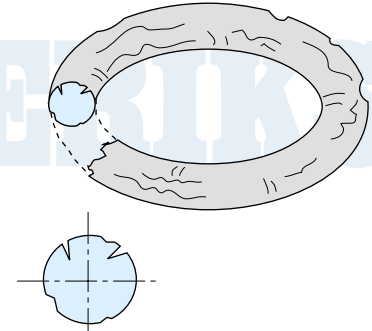
Explosive Decompression

Failure Pattern: marked by random short splits or ruptures going deep into the O-ring cross section. When the O-ring is first removed, the surface may also be covered with small blisters.

Problem Source: absorption of gas by the O-ring while operating in high pressure conditions. Subsequent rapid decrease in system pressure traps within the O-ring micropores, causing surface blisters and ruptures as the gas seeks an avenue of escape.

Picture of an exploded O-ring

Suggested Solution: increase time for decompression; increase material hardness to 80°-95° shore A; reduce O-ring cross sectional size; or specify a decompression resistant material, such as a harder nitrile or special Viton® 514162.

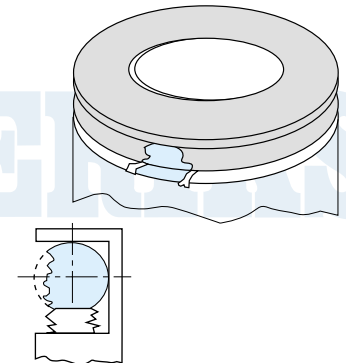
Back-up ring Failure

Failure Pattern: occurring exclusively in dynamic seals, the O-ring surface is notched or nibbled adjacent to the scarf cut or overlap of the back-up ring.

Problem source: thermal changes, pressure surges, and extrusion of the back-up ring into the gap.

Picture of a damaged back-up and O-ring

Suggested Solution: check design details and consider the solid type of back-up ring. Use PEEK (plastic) or another material.
