20. Troubleshooting

O-ring Failure

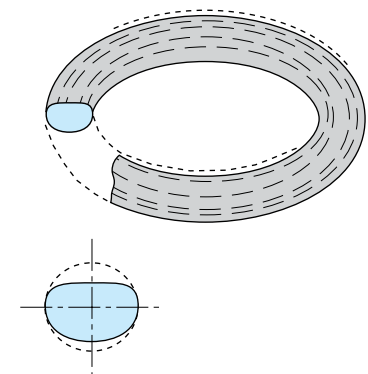
Abrasion

Failure pattern: Occuring primarily in dynamic seals involving reciprocating, oscillating, or rotary motion. This failure pattern can be identified by a flattened surface on one side of the O-ring's cross section or wearlines on the cross section parallel to motion.

Problem Source: Metal surfaces too rough (acting as an abrasive); metal surfaces too smooth, causing inadequate lubrication; poor lubrication; excessive temperatures; or the system is contaminated with abrasives.

Picture of an abrasion affected O-ring

Suggested solution: use recommended metal finishes; provide adequate lubrication; check material compatibility with system temperature; or eliminate abrasive contamination with filters.
